PROJECT PROFILE

PROJECT: Lining Of A Swimming Pool

LOCATION: Israel

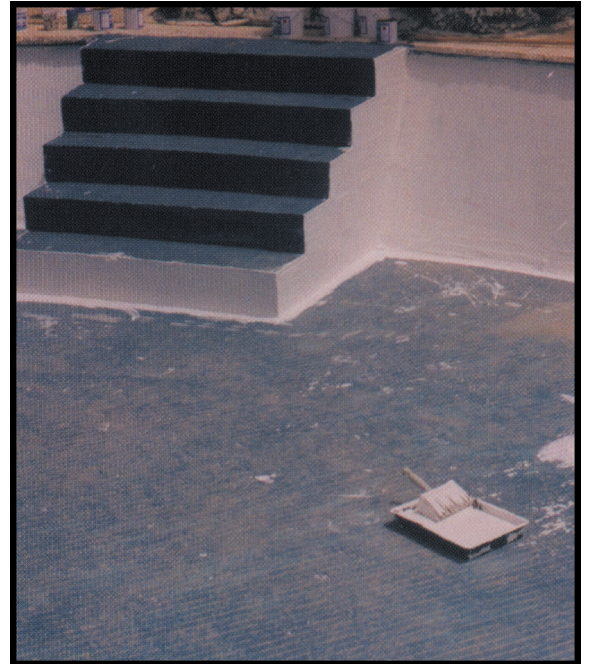
This swimming pool was at the residence of the Turkish Ambassador for Israel. The swimming pool had been allowed to deteriorate badly and all internal surfaces were now in need of complete refurbishment.

The basic structure of the pool was sound, therefore a coating system that would provide good waterproofing and protection was required. The selected coating system needed to offer protection to both the floors and the side walls.

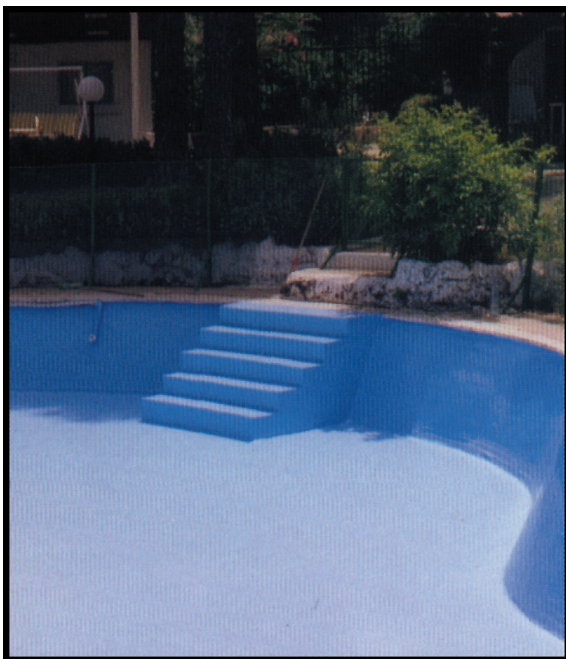
As is evident from the photograph, this coating system has provided an excellent finish, transforming the appearance of this swimming pool.

The swimming pool was first of all cleaned to ensure any contamination was removed from all surfaces. The pool was then allowed to dry out completely before being overcoated with one coat of Uni-Tech GP Primer and two coats of Uni-Tech UV in blue.
