CASE HISTORY

**CENTER PARCS WATER SLIDE
GERMANY**

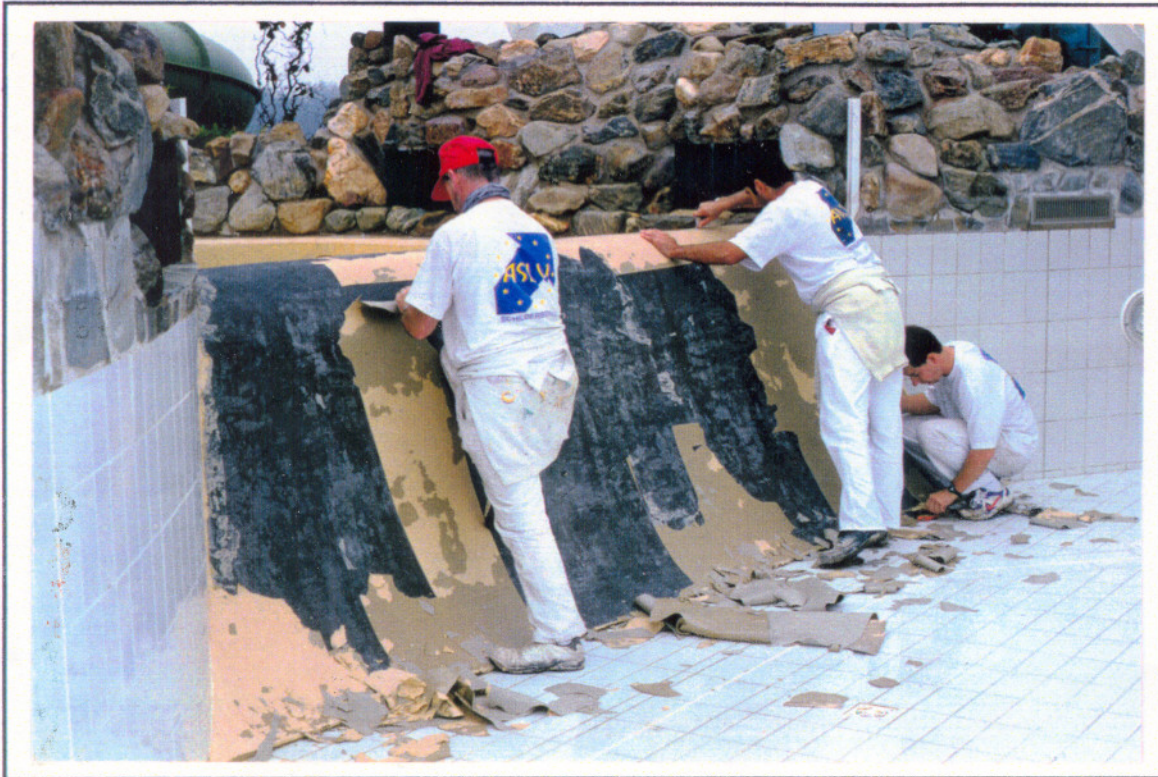
The water slides were constructed with concrete and coated with a number of coats of an epoxy and polyurethane system. However, after six months use, the system began to break down due to the movement of the water slide and the constant immersion which the coating was subjected to.

After extensive testing, the Floor-Tech FB system was chosen. This system required, one coat of Floor-Tech FB Primer, one coat of Floor-Tech FB at a thickness of 300 microns and one coat of Floor-Tech PU at a thickness of 50 microns. The system was applied in October 1995 and has proved a complete success. As a result of this success, the Floor-Tech FB system has been adopted for all their water slides throughout Europe.
