PROJECT PROFILE

PROJECT: Water Tower Refurbishment
LOCATION: Portugal

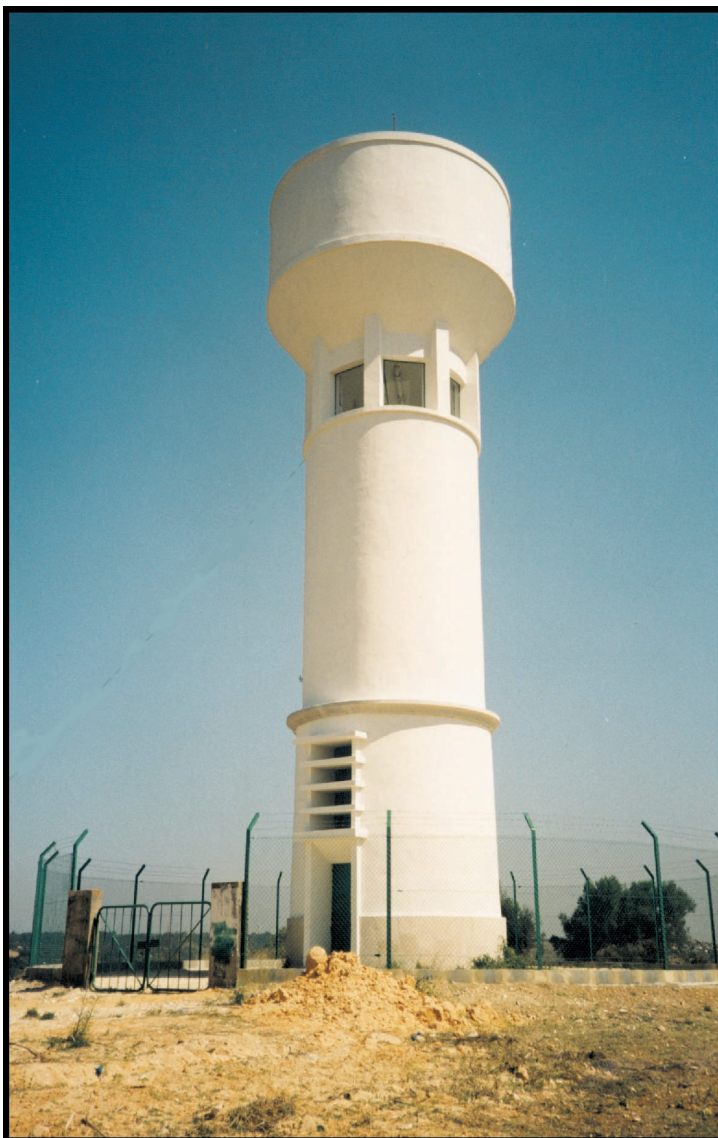
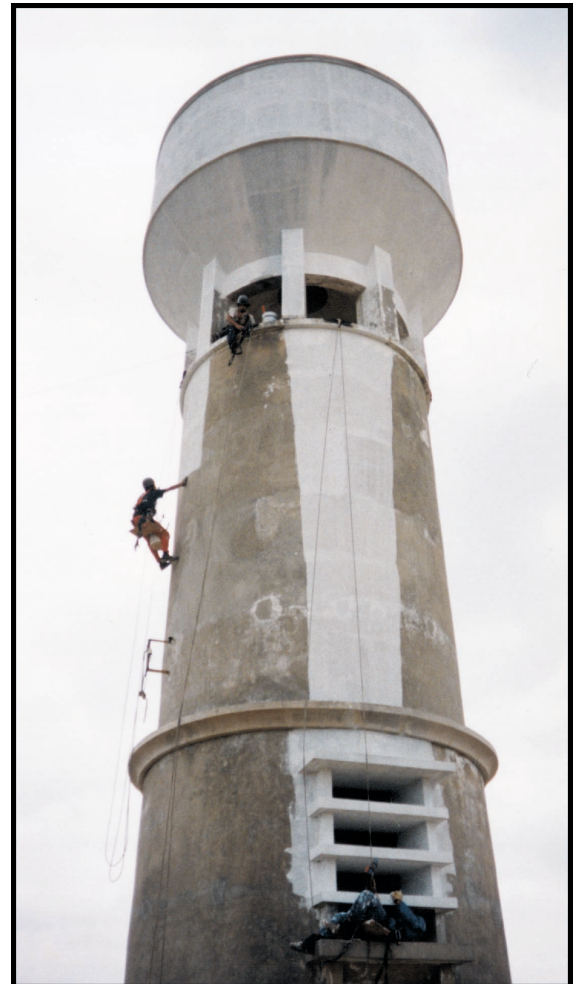
Due to the effects of the environment and time, the external concrete walls of this water tower were in need of refurbishment.

The external surface of the water tower was suitably prepared to ensure that the substrate was clean, dry and free from contamination. The walls were then primed with Uni-Tech GP Primer prior to the application of Wall-Tech FP.

Whilst Wall-Tech FP is micro-porous thus allowing the substrate to breathe, it still has outstanding waterproofing, weatherproofing and anti-carbonation properties. The Wall-Tech FP system offers superior adhesion to external masonry surfaces and optimum levels of flexibility and durability.
